Contract #: 04-0120F4Cty: SF/ALA Rte: 80 PM: 13.2/13.9File #: 69.28**WELDING INSPECTION REPORT****Resident Engineer:**Pursell, Gary**Address:** 333 Burma Road**City:** Oakland, CA 94607**Report No:** WIR-011923**Date Inspected:** 11-Feb-2010**Project Name:** SAS Superstructure**OSM Arrival Time:** 700**Prime Contractor:** American Bridge/Fluor Enterprises, a JV**OSM Departure Time:** 1900**Contractor:** Zhenhua Port Machinery Company, Ltd (ZPMC), Changxing Island **Location:** Shanghai, China**CWI Name:** Mr. Li lin**CWI Present:** Yes No**Inspected CWI report:** Yes No N/A**Rod Oven in Use:** Yes No N/A**Electrode to specification:** Yes No N/A**Weld Procedures Followed:** Yes No N/A**Qualified Welders:** Yes No N/A**Verified Joint Fit-up:** Yes No N/A**Approved Drawings:** Yes No N/A**Approved WPS:** Yes No N/A**Delayed / Cancelled:** Yes No N/A**Bridge No:** 34-0006**Component:** Tower**Summary of Items Observed:**

WELDING INSPECTION REPORT

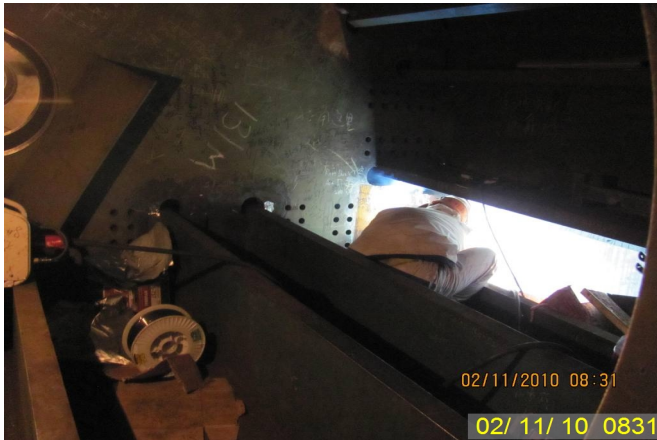
1.This QA inspector, Baskar Govindarajan, observed, ZPMC qualified welding personnel identified as 052930 perform SMAW repair welding on, CD corner of North tower, Lift 4, and weld joint identified as NSTL4-3 B/L-1B. ZPMC CWI Identified as Mr. Yuan hui gang. The welding parameters as measured using QC's calibrated instruments appeared to be in general compliance with WPS-345-SMAW-1G (1F)-Repair.(Photo attached)

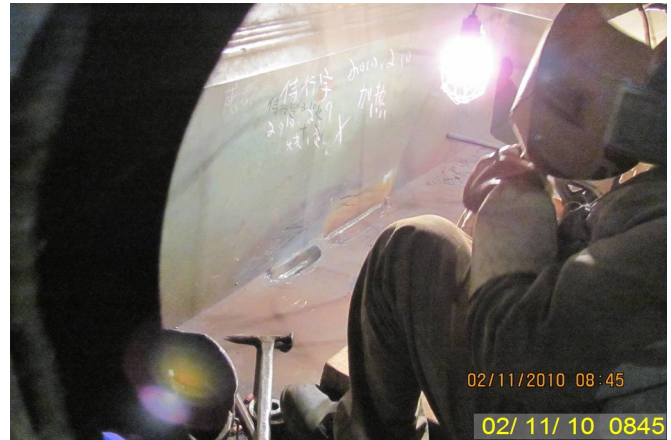
3.This QA inspector, Baskar Govindarajan, observed, ZPMC qualified welding personnel identified as 066477 perform FCAW welding on, inside South tower, Lift 4, Skin A fit lugs on 131 mtr. Elevation and weld joint identified as SSTL4-1 G/L-103, 101. ZPMC CWI Identified as Mr. Li lin. The welding parameters as measured using QC's calibrated instruments appeared to be in general compliance with WPS-B-T-2333-T-C-P4-F.(Photo attached)
